RILEM TC 277-LHS report: lime-based mortars for restoration—a review on long-term durability aspects and experience from practice

Keywords Lime-based mortars · Binding mechanism · Long-term durability · Damage cases · Practice

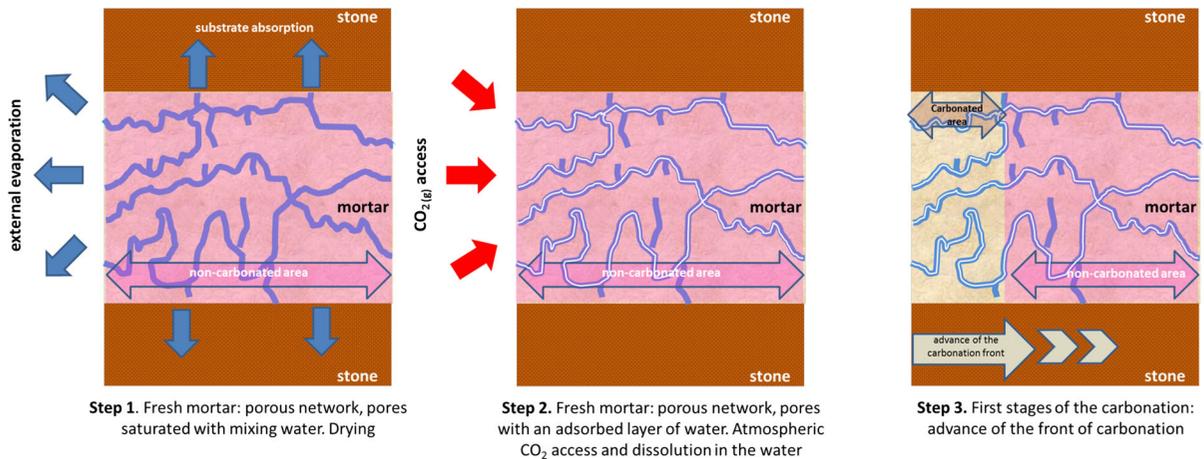
Fig. 1 Scheme of the carbonation process of an air lime bedding mortar of stone masonry. Step 1: drying; Step 2: CO_2 access and dissolution in the adsorbed layer of water; Step 3: carbonation front advance

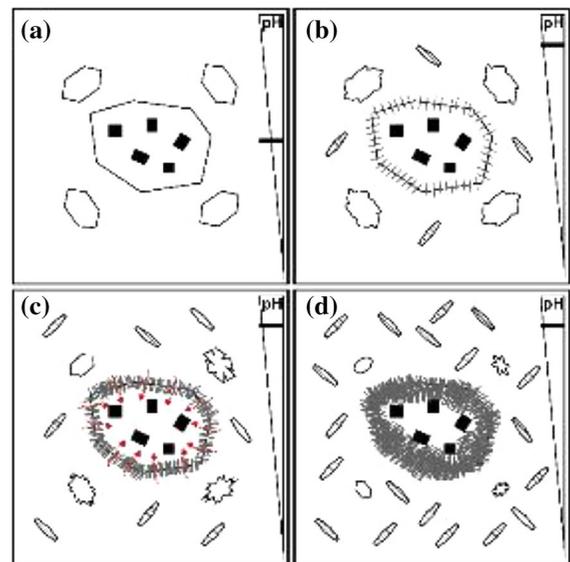
Fig. 2 Scheme of the pozzolanic reaction process: **a** Initial state (portlandite crystals depicted as hexagonal polygons, pozzolanic particle depicted as a large polygonal shape with non-reactive mineral constituents in black); **b** Initial dissolution period (C-S-H crystals depicted as grey lines, C-A-H crystals depicted as elongated textured polygons); **c** Induction period (red dashed arrows indicating water diffusion through osmosis); **d** Main reaction period

form hydrated reaction products (calcium silicate and calcium aluminate hydrates) with marked binding properties related to their crystalline structure [44]. Pozzolanic reaction processes can be subdivided into three reaction stages (Fig. 2) [45], namely initial

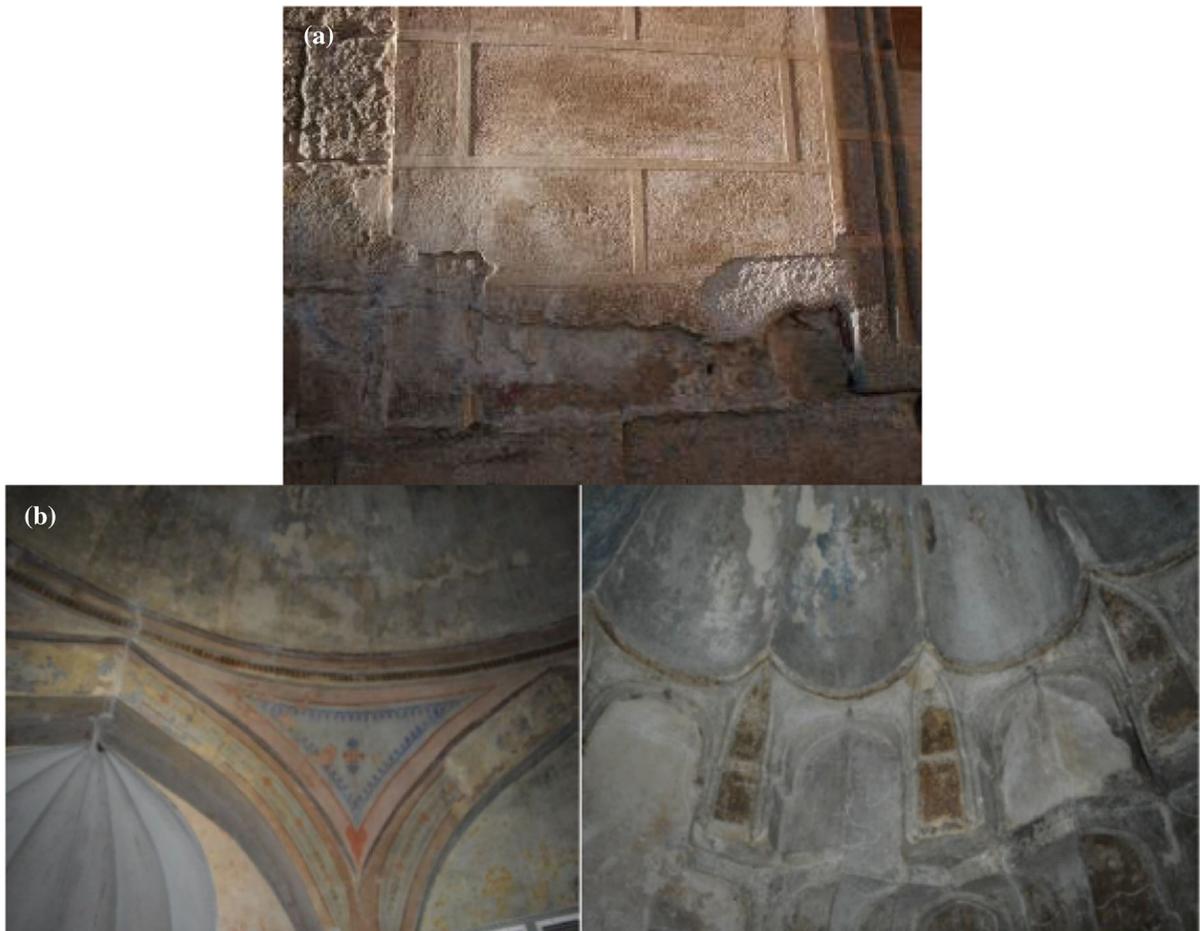
Fig. 3 **a** Durability of air lime render imitating stone over stone masonry in Évora Cathedral, in Portugal (seventeenth century); **b** Interior of Pasa Hamam, Thessaloniki (1530 AD), with well-

preserved air lime renders ($\text{CaO} \geq 55\%$) although soluble salt content was high $\geq 1\%$

Many ancient constructions, all over the world, are composed of masonry with air lime mortars, thus proving the high durability and fitness for use of this material [74–79]. Due to their low modulus of elasticity, air lime mortars can follow the movements of the structures with minor cracking, also ensuring optimal adhesion. Furthermore, the high porosity and water vapour permeability of the mortars allow quick drying of walls, with evaporation of internal moisture to the exterior, thus contributing to a healthy internal environment and to the good condition of the walls. The slow hardening mechanism by carbonation ensures an improvement of performance along time and contributes, together with the self-healing properties, related with dissolution–recrystallization cycles of calcium carbonate, to a high durability, if destructive actions (by nature or by human activity) do not occur (Fig. 3).

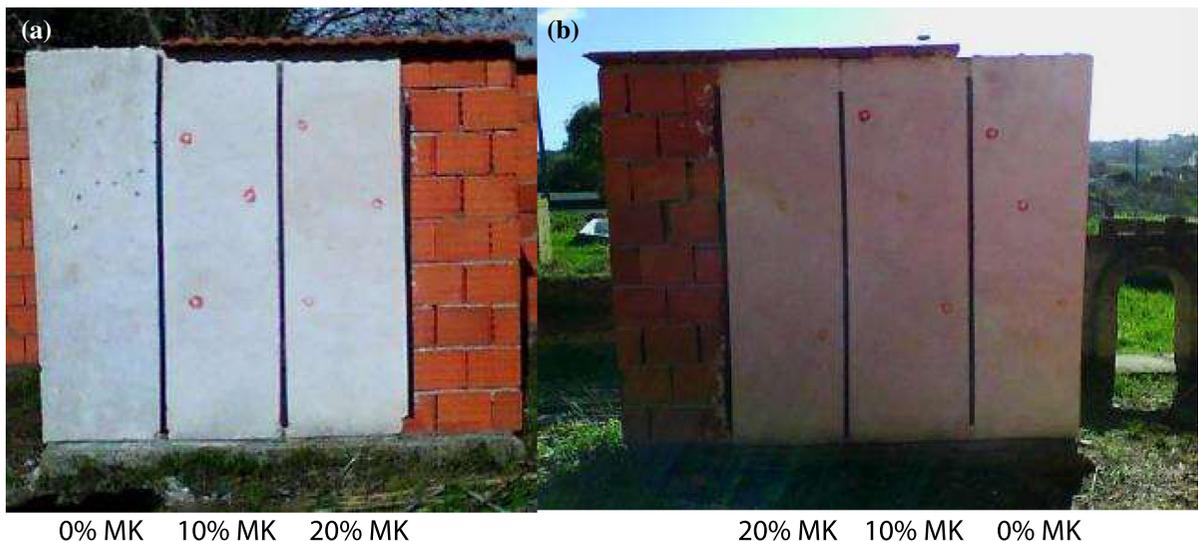
Fig. 4 Experimental pure air lime renders and air lime-metakaolin (MK) renders (marked with the percentage of MK replacing lime) after 7 years of natural exposure **a** South and **b** North, in a semi-urban environment 3 km from the Atlantic Ocean

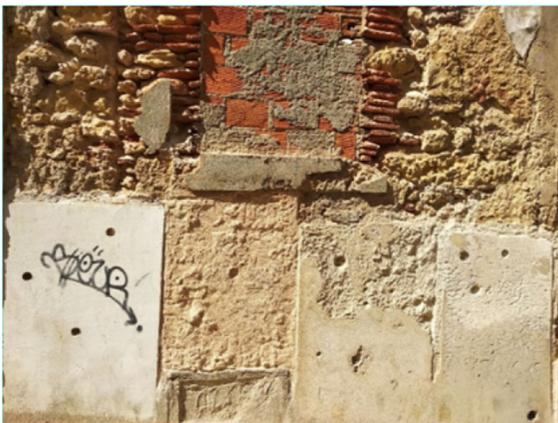
Fig. 5 Experimental panels applied on an ancient wall in the Historic Centre of Palmela (Portugal), 12 years after application: second from the left is air lime + MK and third from the left is has air lime as the only binder

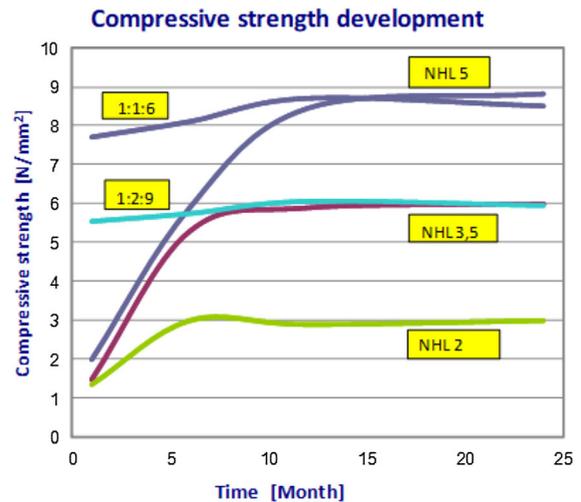
Fig. 6 Slow strength development for the NHL mortars and quick hardening of the cement-lime mortars: NHL mortars, 1:2.5 (NHL: sand) in vol.; cement-lime mortars e.g. 1:1:6 (cement: lime: sand), in vol.; curing conditions 20 °C and RH 90% [99]

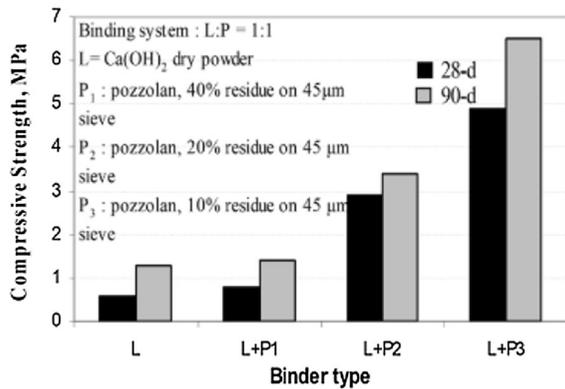
Fig. 7 Influence of fineness of pozzolan (after grinding) on mortar's strength development

tested by preparing mortar mixtures with lime and siliceous sand 0–4 mm (L:P 1:1, B/A 1:3 by mass). The water added responded to a flow of 15 cm (according to EN 1015-3). Curing conditions were the following: moist curing > 90% RH for P1, P2, P3 mortars and dry curing 60–65%RH for L mortar [100].

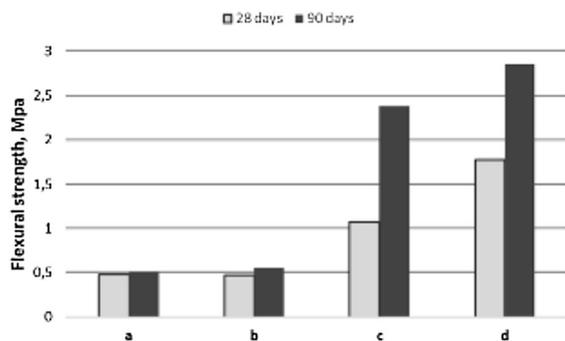
Fig. 8 Effect of curing regime on flexural strength development of lime:pozzolan (1:1) mortars. a: natural curing; b: based on EN 459–2, 2015 “Building lime”, concerning standard mortar; c: concerning hydraulic lime; d: based on ASTM C 311, strength activity index with lime

Furthermore, as previously mentioned, moist curing conditions are essential for pozzolanic reaction, as showed in Fig. 8. Volcanic natural pozzolan (after grinding to 10% residue on 45 μm sieve) was used with lime powder (CL90) for the manufacture of the mortar, together with a standard CEN sand (B/A ratio 1:3 by mass). The water content was adjusted to have 14.5 cm flow (measured according to EN 1015-3).

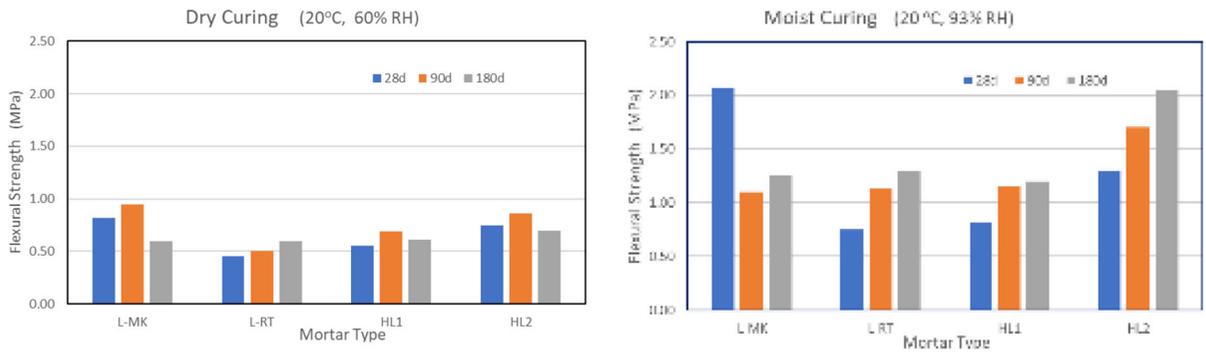
Fig. 9 Flexural strengths values for Lime-Metakaolin (L-MK), Lime-Rhenish trass (L-RT), and two types of Natural Hydraulic Lime (HL1 and HL2) mortars, for 2 curing conditions: dry curing and moist curing (adapted from [58])

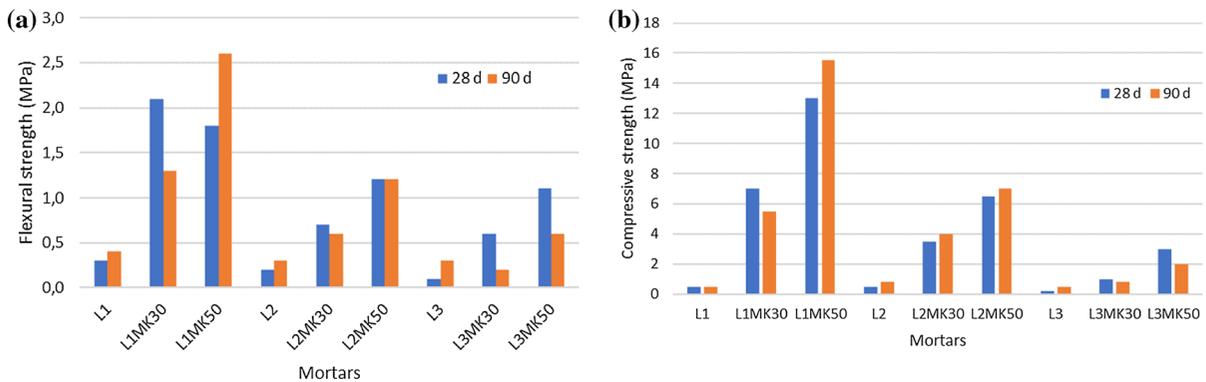
Fig. 10 Flexural a) and compressive b) strengths of air lime-metakaolin mortars with ratio b/a 1:1, 1:2 and 1:3 (wt) and ratio MK/L 0, 0.3 and 0.5 (adapted from [68])

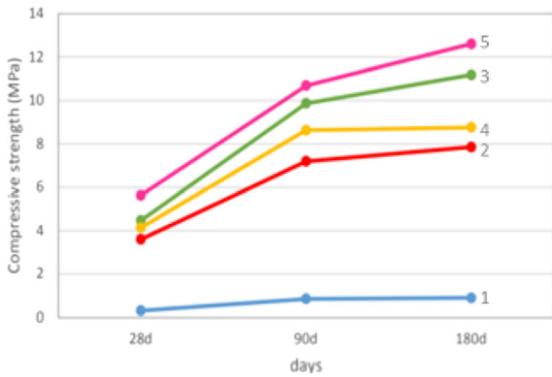
Fig. 11 Long term strength of lime-based mortars with: 1 lime powder CL90, 2 lime:natural ground pozzolan (1:1), 3 lime:natural ground pozzolan (1:1) (with coarse aggregates), 4 NHL 3.5, 5 lime:pozzolan:cement (1:0.7:0.3)

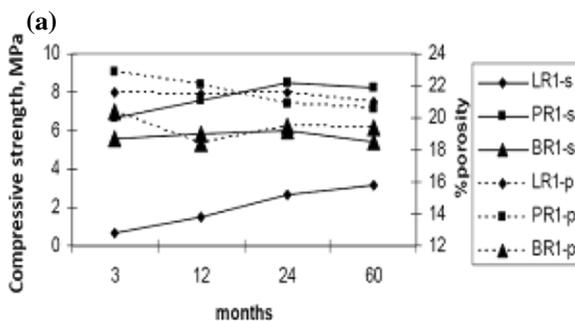
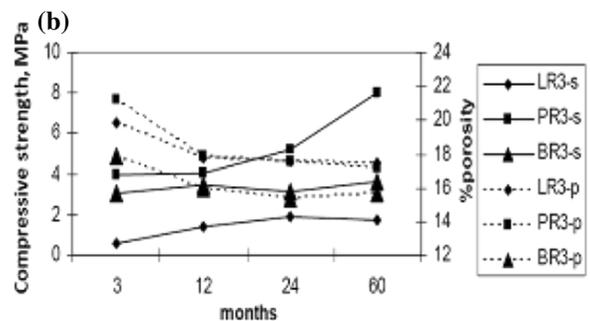
Fig. 12 **a** Evolution of compressive strength (-s) and porosity (-p) in mortars of binder/aggregate ratio 1/1 (R1); **b** Evolution of compressive strength (-s) and porosity (-p) in mortars of binder/

aggregate ratio 1/3 (R3). L: Hydrated lime CL90, P: Lime-natural ground pozzolan (1:1) (by mass), B: Lime:pozzolan:brick dust (1:0.5:0.5)

mortars of comparable ratio. Indicative results of compressive strength are reported in Fig. 12. It seems that strength evolution is in general stabilized at the age of 12 months. The slight differences in strength with age (up or down) are related rather with microcracking due to drying shrinkage of specimens.

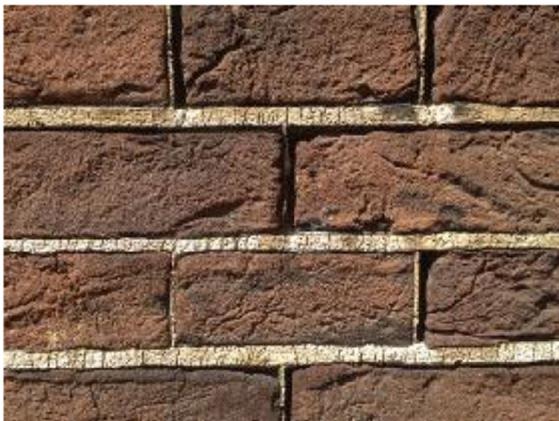
Fig. 14 Cut to shape pointing, with typically very high binder content, showing shrinkage cracks

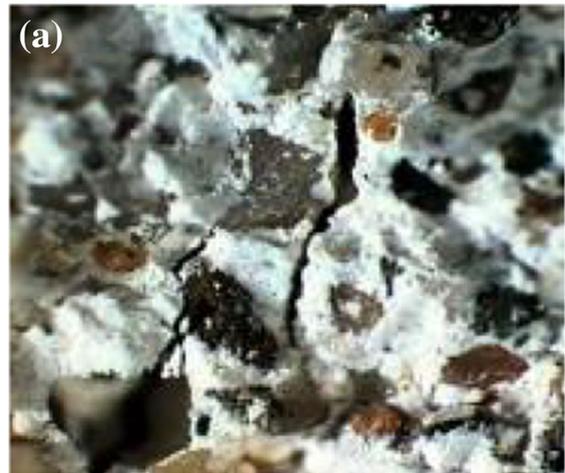
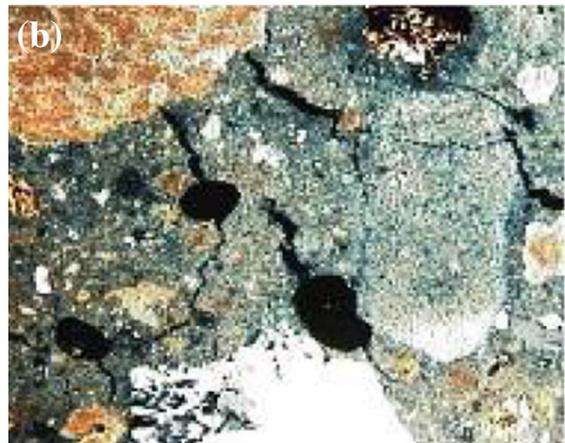
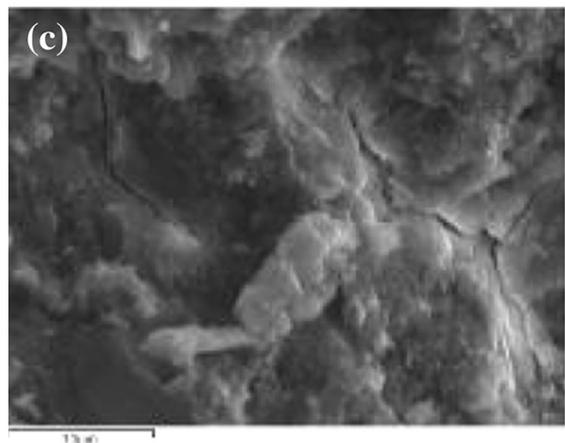
Fig. 15 **a** Shrinkage in a lime mortar (stereoscope $\times 8$); **b** Mortar cracking under polarized microscope ($\times 150$); **c** Mortar cracking under SEM ($\times 1000$)

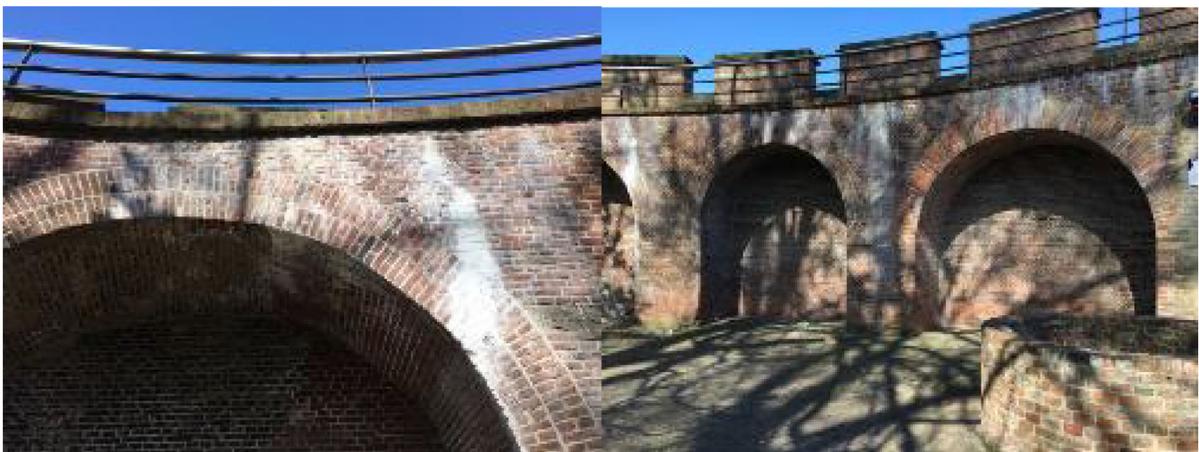
Fig. 16 Lime leaching after repair of historic masonry; see also 4.7

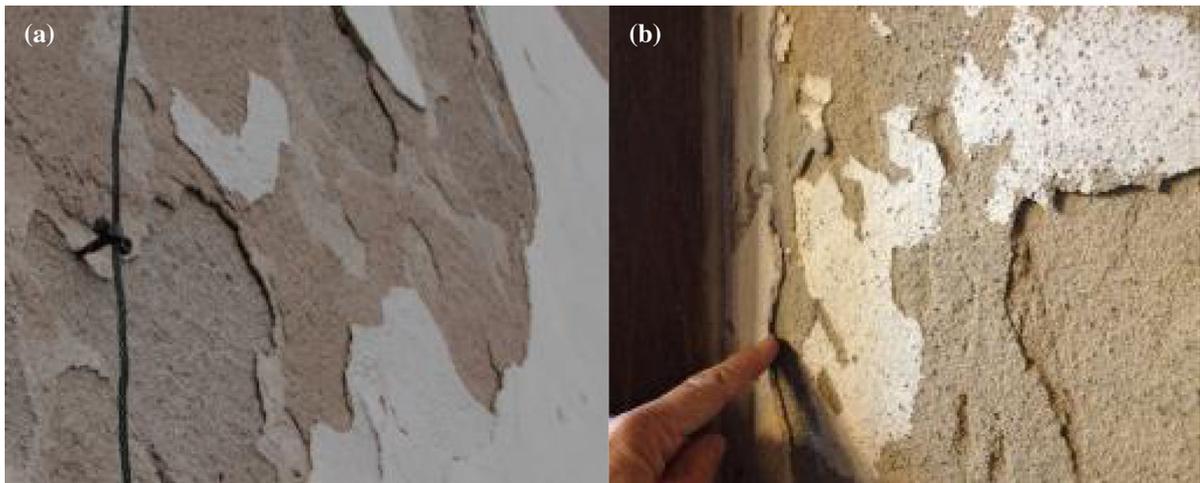
Fig. 17 Typical forms of layering in renders and plasters. Separate render layers coming off due to freezing temperatures in a saturated and porous render (a), [110]; similar damage, due to salt crystallization in a plaster, applied on a wall with capillary rising damp (b)

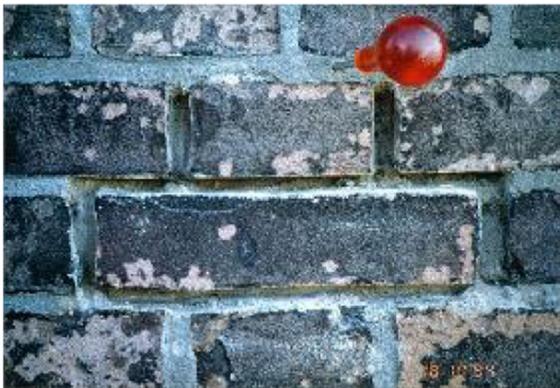
Fig. 18 Weak, decayed trass lime re-pointing

In this case indeed the lime reacted only with carbon dioxide from the air. Lime converted into calcium carbonate is no longer available for the trass-lime reaction. As the trass did not react, it acts just as a filler and a very weak mortar results.

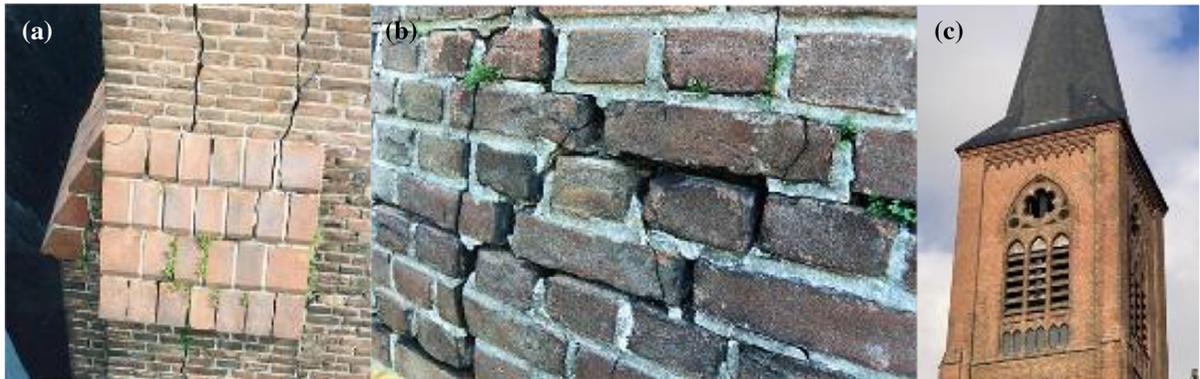
Fig. 19 Cracks in masonry, caused by expansion of bedding mortar, deeper in the wall section, due to formation of thaumasite (a); push out of the pointing is a secondary effect (b); situation several years after repair: no recurrence (c)

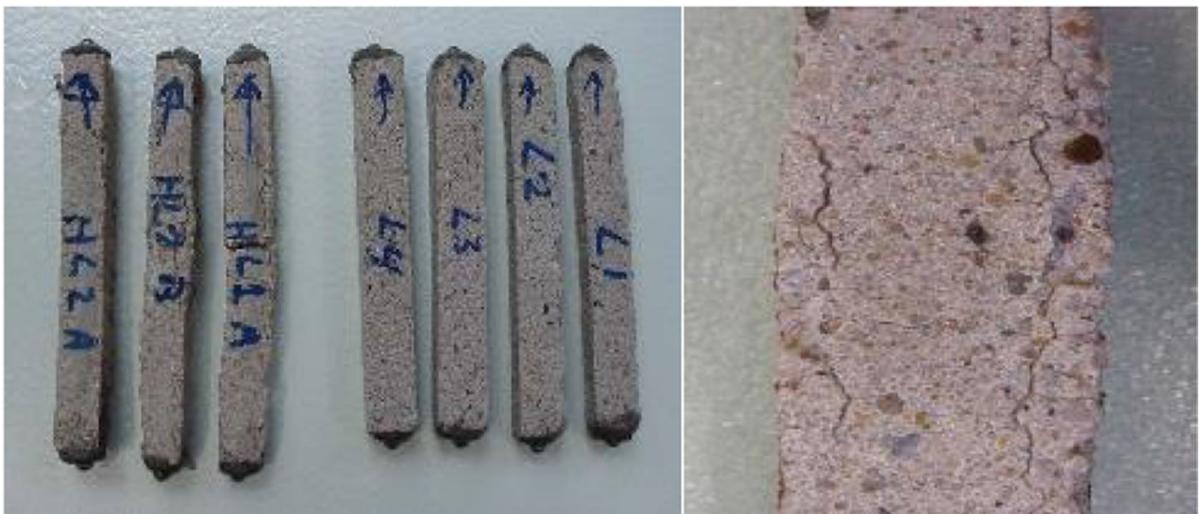
Fig. 20 Mortar prisms after 15 weeks in sulfate solution. Natural Hydraulic Lime based (NHL) specimens with clear expansion and deformation and Hydrated lime based (CL)

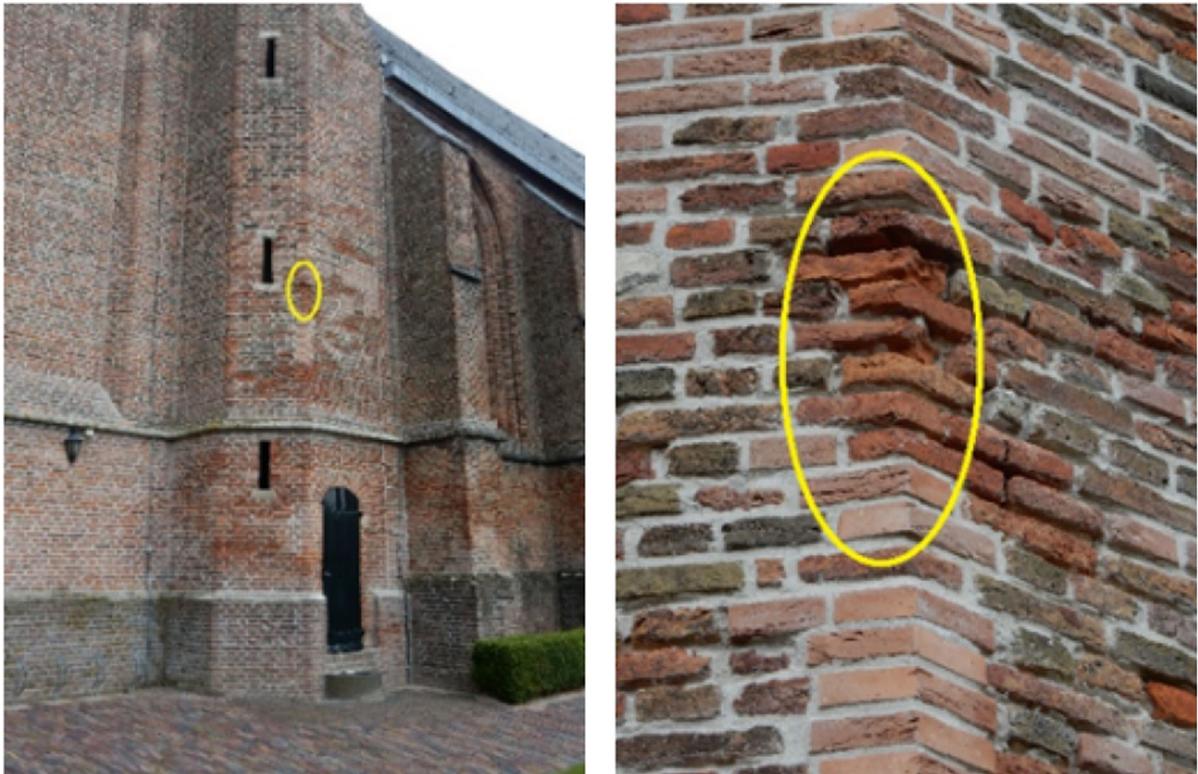
Fig. 21 Situation of the damage in 2016. Left, the reddish parts of the masonry indicate where the repointing is damaged. Right, detail of one of the spots with damaged repointing

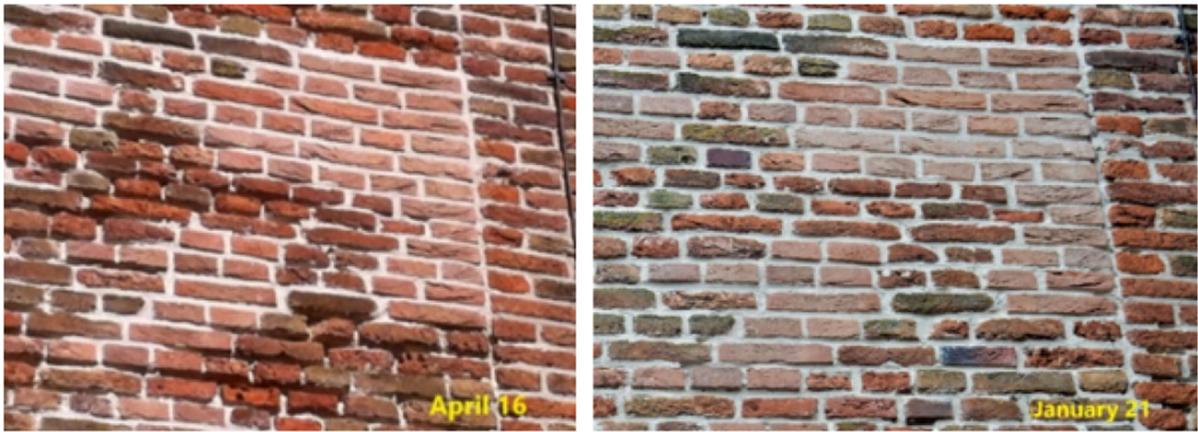
Fig. 22 Comparison of part of the south wall in April 2016 (before repair), respectively January 2021. Most of the underfired bricks are still in place (some of the weakest were replaced). The repair repointing performs rather satisfactorily

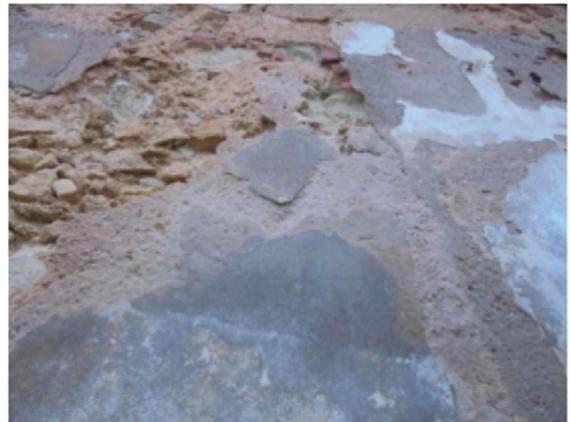
Fig. 24 Detail of the degradation showing cementitious repair mortars

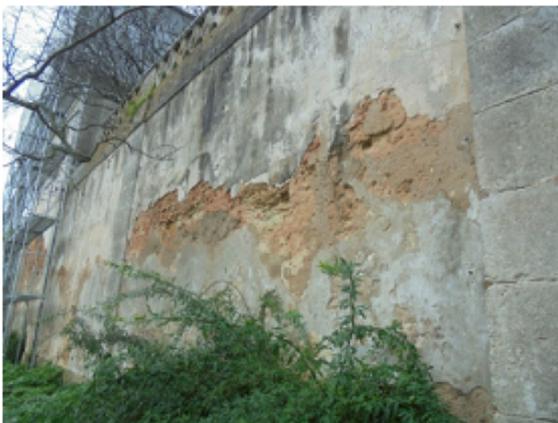
Fig. 23 Degradation on the East façade

The main types of degradation observed on the most degraded façade consist of crumbling and loss of adhesion of the render, in a zone of the wall in between 1.40 and 1.80 m from the soil.

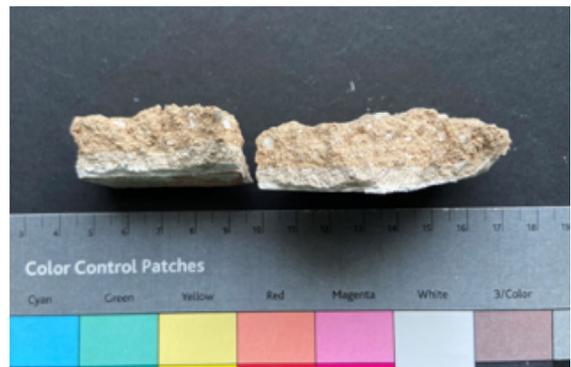
Fig. 25 Samples of the old lime render in two coats

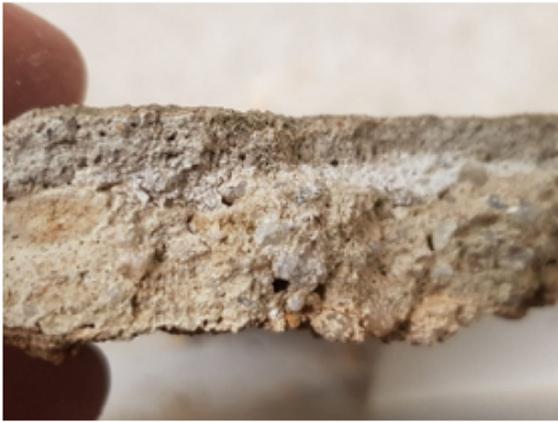
Fig. 26 Sample of the render of the East façade with a cementitious repair coat

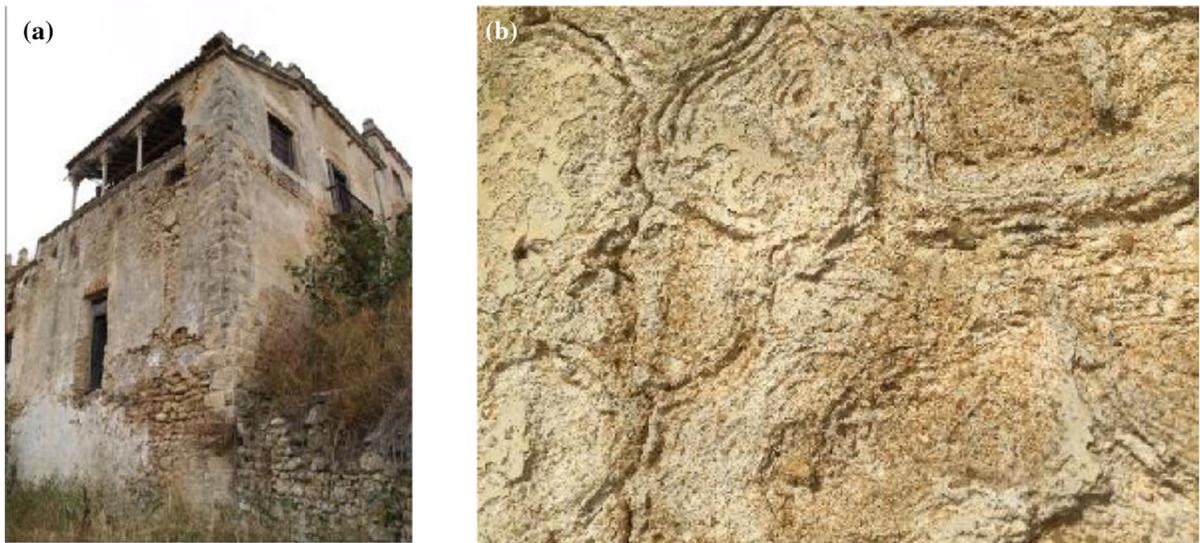
Fig. 27 Valflores Palace in St. Iria da Azoia, Loures, Portugal (a), and Liesegang phenomenon in a rendered façade (b)

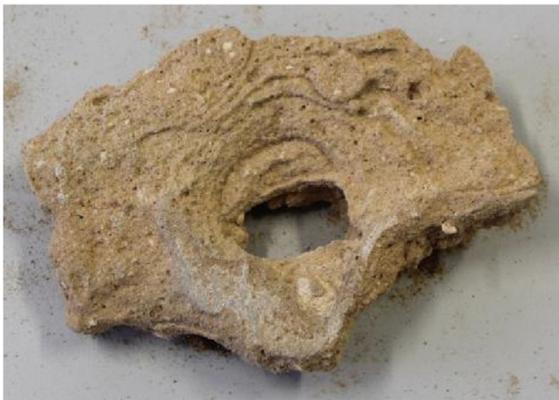
Fig. 28 Deep circular erosion on a render sample of Valflores Palace

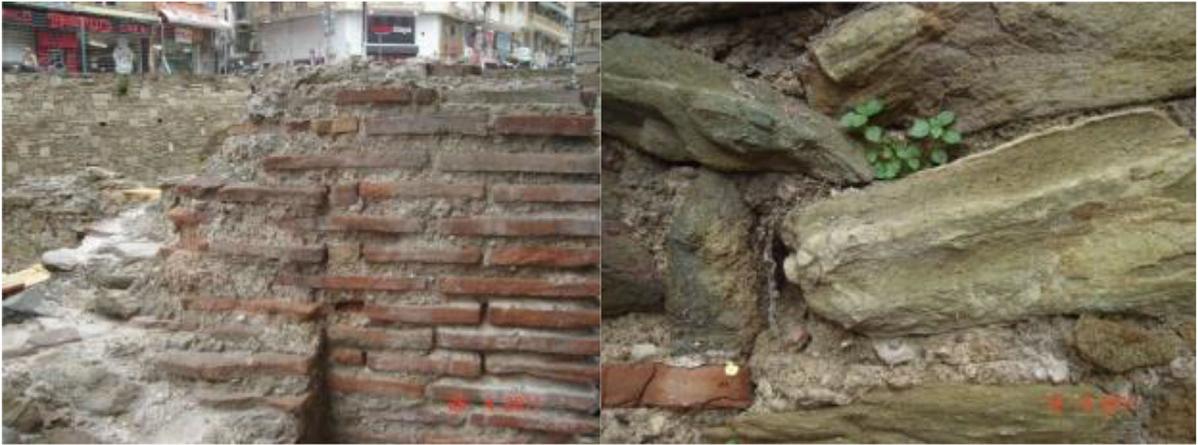
Fig. 29 Deterioration problems of the masonries before the intervention works

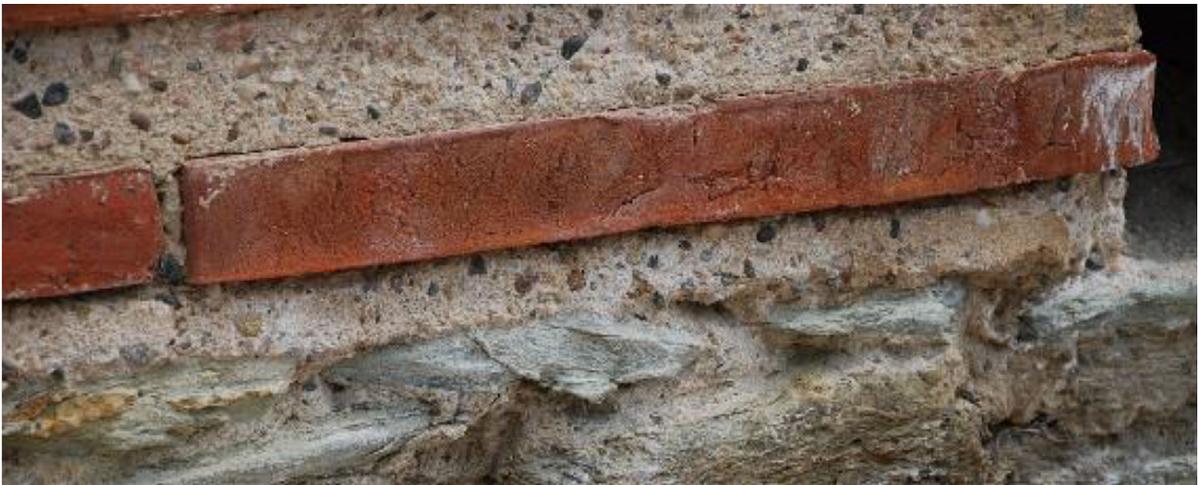
Fig. 30 Repair mortar in a mix structural system of Galerius Palace in Thessaloniki, Greece

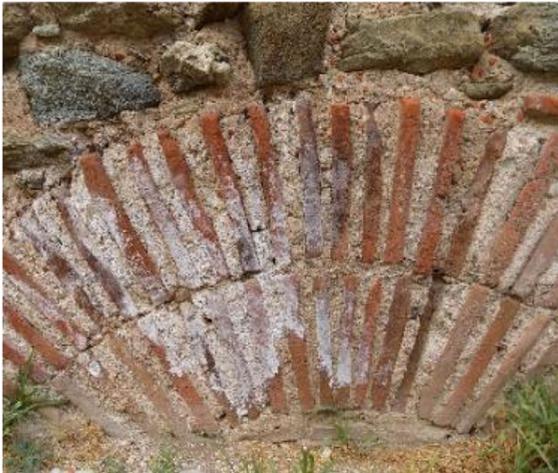
Fig. 31 Efflorescence near to the ground level

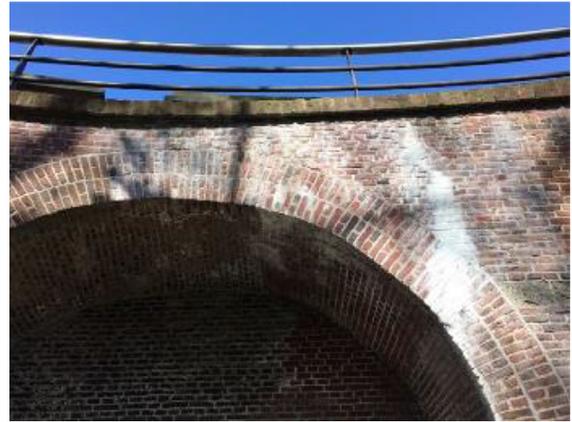
Fig. 33 Arch section in the masonry of the motte castle of Leiden, after reconstruction of the section

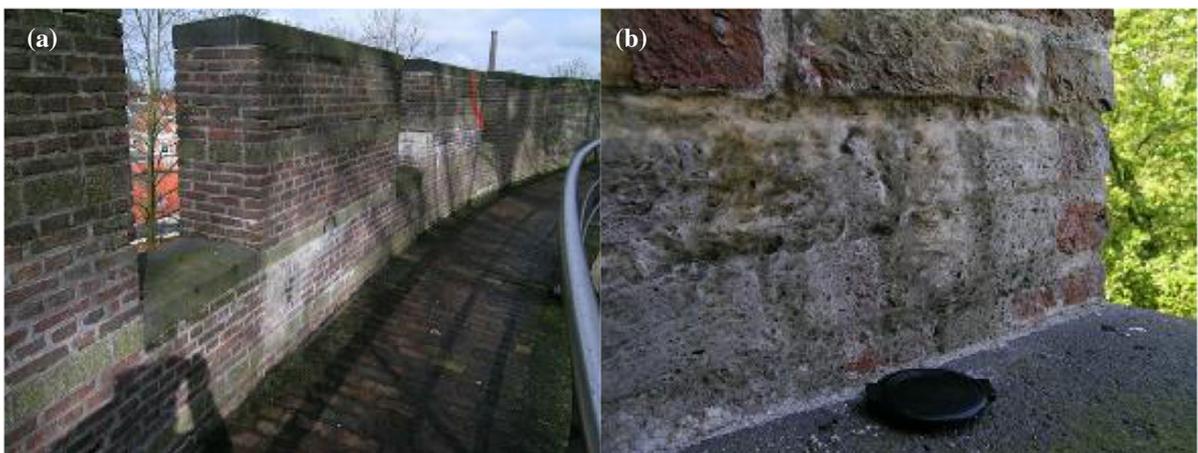
Fig. 32 a) Encrustation, due to leaching of mortar in very exposed masonry, the battlements of a motte castle; b) Detail
